The Dyckman Farmhouse: An Architectural Analysis

Art 1630H: American Architecture

Yeshiva College

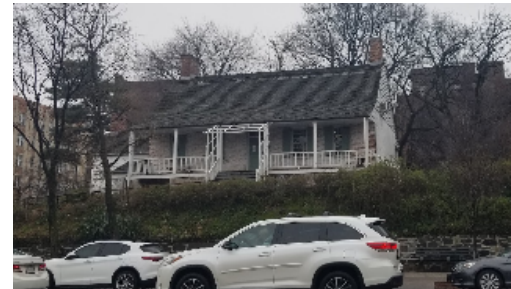
Figure 1: The house sits high above the street

The Dyckman farmhouse is situated roughly five feet above the street, requiring one to ascend a flight of stairs to reach the property (Figure 1). As can be seen in the picture, the farmhouse towers over the street, as if having traveled in time from the past. The stone, white-washed brick, and wood two-story house (with a full

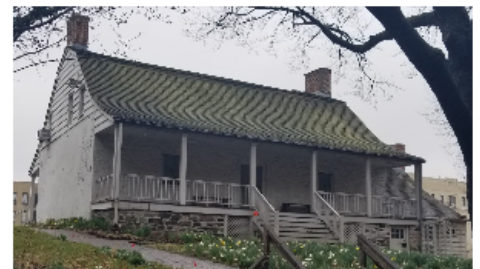
Figure 2: The gambrel roof and identical porch

The gambrel roof covering the farmhouse is shingled (Roth 49). The two sides converge at the top of the house and flare outwards. This offers the front porch, as well as the back porch, which is identical to the front porch, protection (Figure 2).

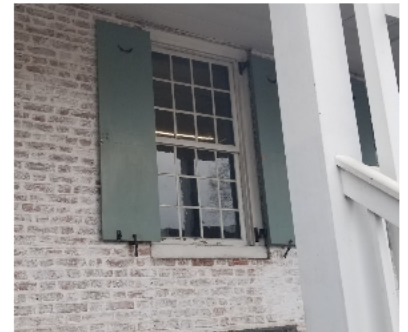
Figure 3: The white-washed red brick and green shutters

William Dyckman primarily used brick, stone, and wood to build the farmhouse. The front of the house is made of white-washed red brick, while the back is stone. Windows along the front and rear feature green shutters with crescent moon cutouts (Panetta 398) (Figure 3).

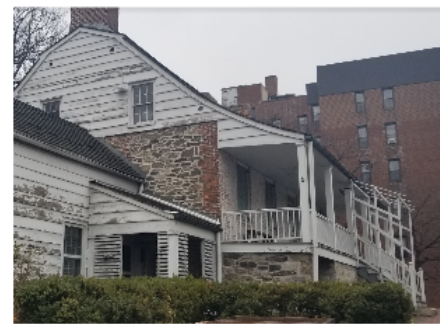
Figure 4: Fieldstone and clapboard walls

Double-flue chimneys located on either ends of the roof are made of brick. The side walls are made of random fieldstones with heavy mortar joints, and the side walls below the roof are finished with wood overlapping clapboards (Figure 4).

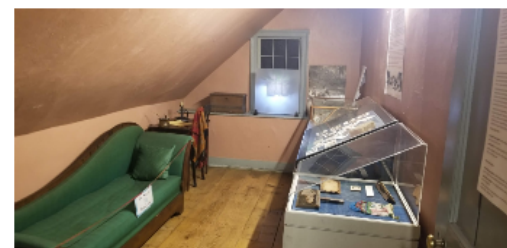
Figure 6: The pink walls of a room

Interior materials and finishes also conform to the late eighteenth-century Dutch model. Wooden lath, horsehair, and straw comprise the walls which are painted a pinkish color (Figures 5 and 6). Dado rails painted white, run along the walls. The floors are made of wide pine boards, while the ceiling is covered in plaster (Heintzelman) (Figure 7).

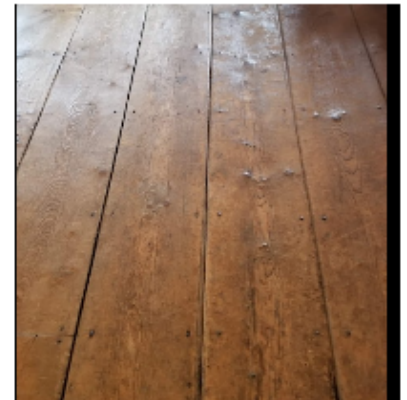
Figure 7: The pine floor

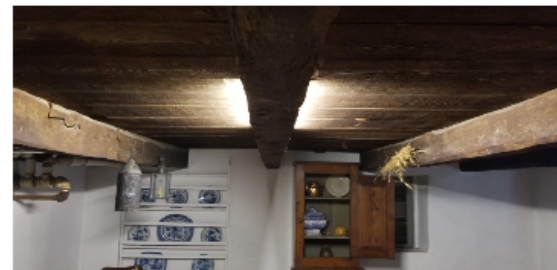
Figure 8: The beams in the basement

The Dyckman farmhouse relies on a wood frame to support its floors and roof. In the basement, large, exposed wooden beams run the length of the room (Figure 8). The boulder upon which the house was built also provides some structure and support (Comstock 330) (Figure 9). This boulder can be seen when descending the stairs leading to the basement.

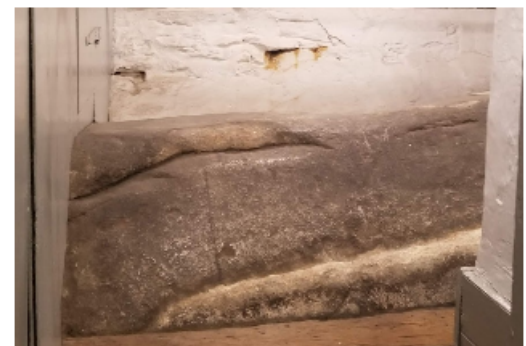
Figure 9: The boulder

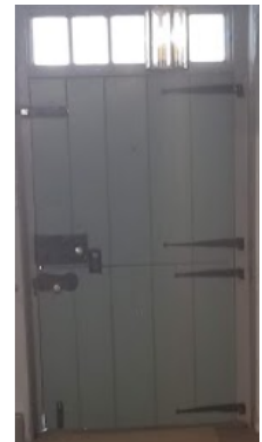
Figure 14: Barn doors

In addition to the gambrel roof, the Dyckman farmhouse features several characteristics typical of Dutch farmhouses. One such feature is the Dutch barn doors, situated in front and back of the house, directly aligned with each other (Figure 14). These doors are split into top and bottom halves which can swing independently. In the summer, this design allows for a cross breeze to travel through the house, while leaving the bottom halves of the doors closed. A cupboard sits in the corner of the room (Figure 15). The front looks like a normal cabinet, but instead of a rectangular build, its back is rectangular and fits snugly against two walls.

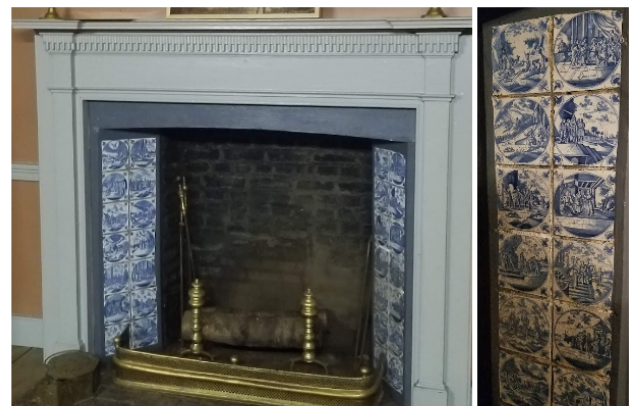
Figure 16: The fireplace and Figure 17: Close-up of the Dutch China

Other Dutch features can be found throughout. The fireplaces on the upper two floors feature pilasters and dentil cornices. One fireplace, located on the main floor, has Delft Blue (Dutch) tiles, which look very similar to China tiles, surrounding it (Figures 16 and 17). The tiles are blue on white, and depict people doing various activities, like congregating in the city. The fireplace in the basement lacks any ornamentation, is made entirely of brick, and has a flat arch (Figure 18). Furnishings in the house

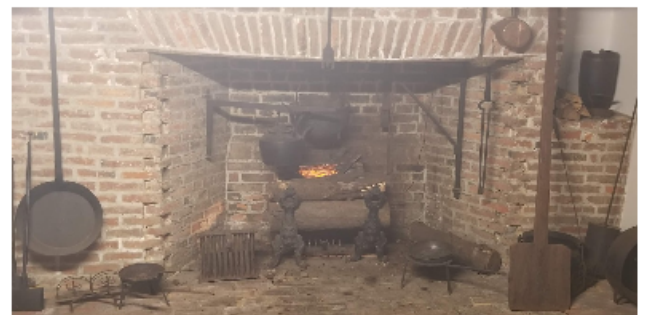
Figure 18: The winter / brick fireplace

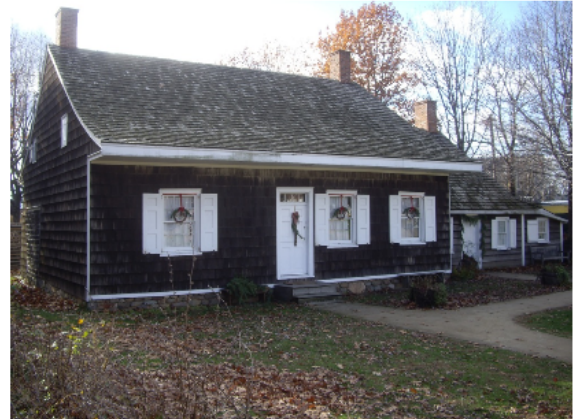
Figure 19: The Peter Wyckoff House

The tristate area features many examples of Dutch colonial architecture. The Wyckoff House in Brooklyn, like the Dyckman farmhouse, features a gambrel roof, shuttered windows, and additions to the house located on the side though not at the back (Figure 19). The Dyckman house, for example, once featured a summer kitchen on the south side, as well as a section on the north side, about which not much is known since it burnt down. Both houses have side walls made of clapboards, wood shingles, and brick chimneys on opposite ends of the house
